To remove and change rear kit on 1U NVP series

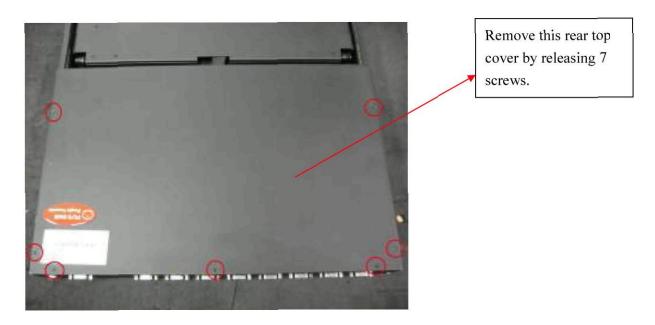
Step 1: Remove the top rear cover behind the LCD panel

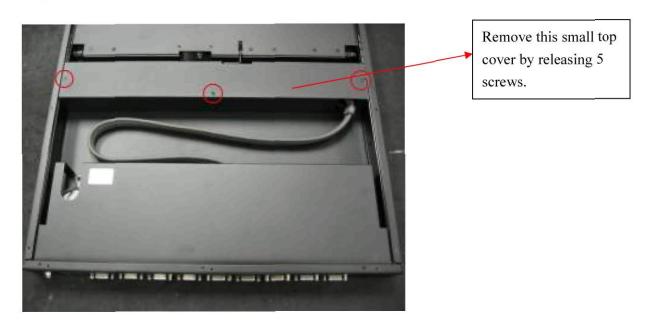
Step 2: Remove the small top cover behind the LCD panel.

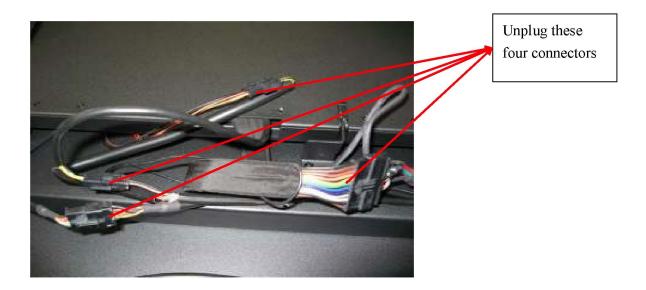
Step 2: Unplug four connectors from the original unit as shown below, then reconnect those back on the new KVM rear kit carefully.

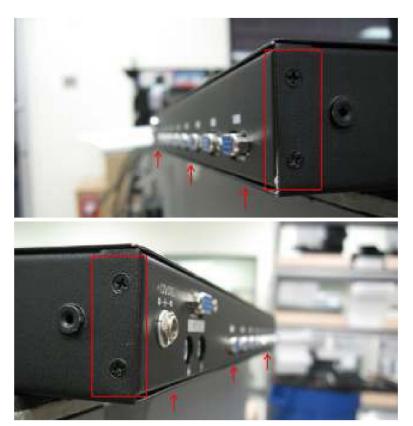
Step 3: Remove the rest of rear kit screws (3 on the bottom, 2 on each sides)

Step 4: Finally, please follow Step 3 to Step 1 to install back the rear kit, small cover & top cover to complete the procedure of replacement.
